Survey identifies sediment sources in North Coast rangelands

David J. Lewis □ Kenneth W. Tate □ John M. Harper □ Julie Price

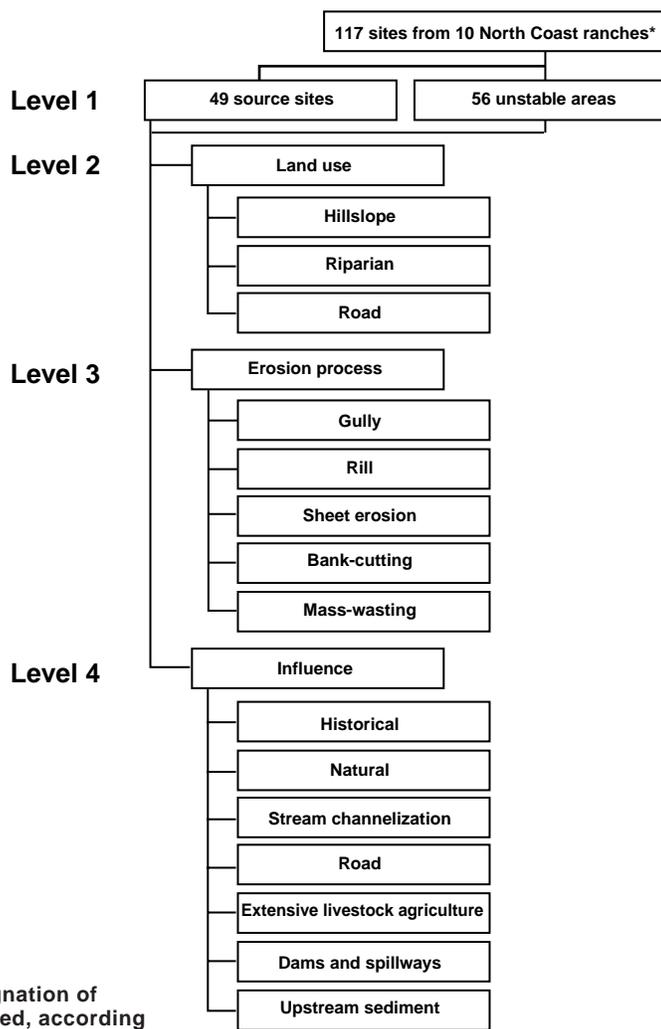
Fig. 1. Designation of sites surveyed, according to inventory designation.

*117 includes 12 noninventory sites

Site classification. We first classified each sediment delivery site as a source site, unstable area or noninventory site according to NCRWQCB site-selection criteria established in the Garcia River sediment TMDL (NCRWQCB 1998a; fig. 1):

The 117 sites were first grouped by inventory designation to assess sediment delivery from source sites, unstable areas and noninventory sites (fig. 1). Source sites and unstable areas were then grouped by landscape position and erosion processes. Land-use types were divided according to three landscape geographic positions: hillslope, riparian and road. Finally, source sites and unstable areas were sorted by influence, including historical, natural, stream channelization, roads, extensive livestock agriculture, dams and spillways, and upstream sediment.

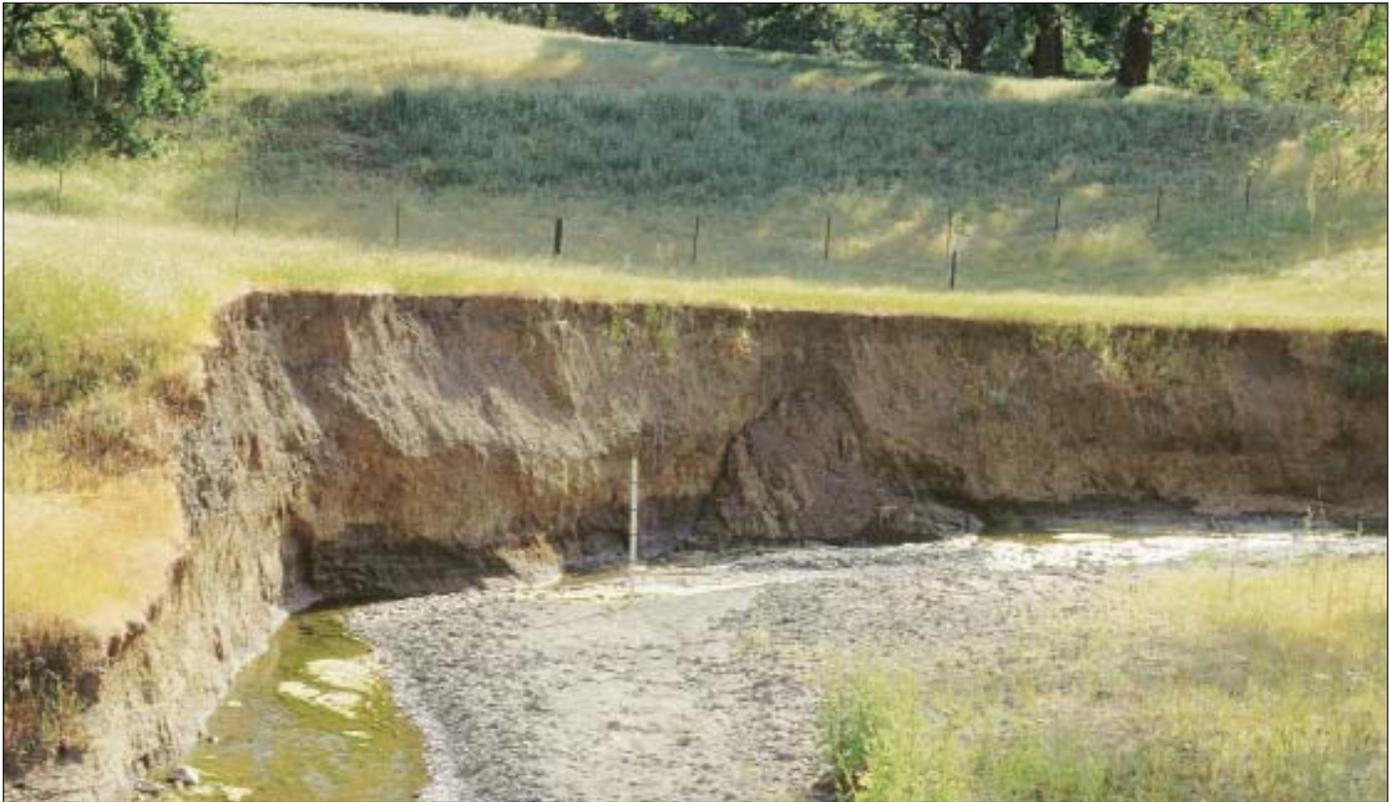
Unstable area of sediment delivery associated with bank-cutting and resulting from historical and natural influences. Current water-quality regulations require inventory and monitoring but not mitigation of this site.

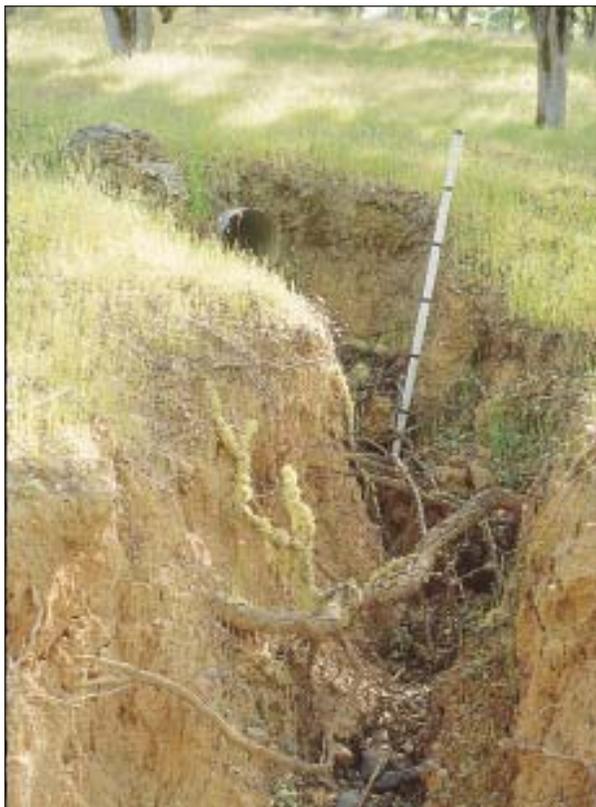
Source site of sediment delivery associated with gully erosion and resulting from road drainage management and culvert design. Current water-quality regulations require inventory, monitoring and mitigation of this site.
