Visual Assessment of Riparian Health

T. A. WARD, Livestock and Natural Resource Advisor, University of California Cooperative Extension, Stanislaus and San Joaquin Counties; **K. W. TATE**, Extension Rangeland Watershed Specialist, Department of Agronomy and Range Science, University of California, Davis; **E. R. ATWILL**, Associate Veterinarian and Associate Specialist, Department of Population Health and Reproduction, University of California, Davis.

Publication 8089

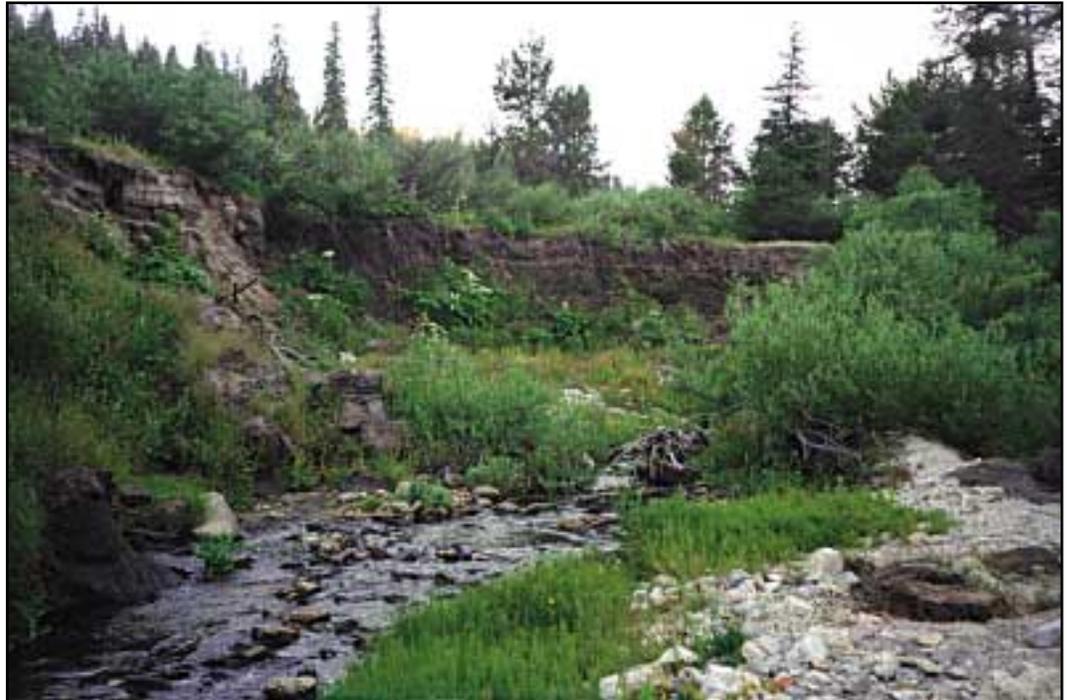
Figure 2. Channel condition. This creek scores a 3 since it no longer has access to the floodplain. See figures 3, 15, and 16 for more examples of scoring for channel condition.

This question determines whether a creek has experienced downcutting in the past, restricting full utilization of the floodplain. The score is lower if downcutting is currently active. A channel condition question was present on all assessments. It was found to be significant (NRCS: $p=0.001$; EPA: $p<0.001$; PFC: $p<0.001$) at predicting final habitat scores (NRCS: $R^2=0.998$; EPA: $R^2=0.997$; PFC: $R^2=0.757$).

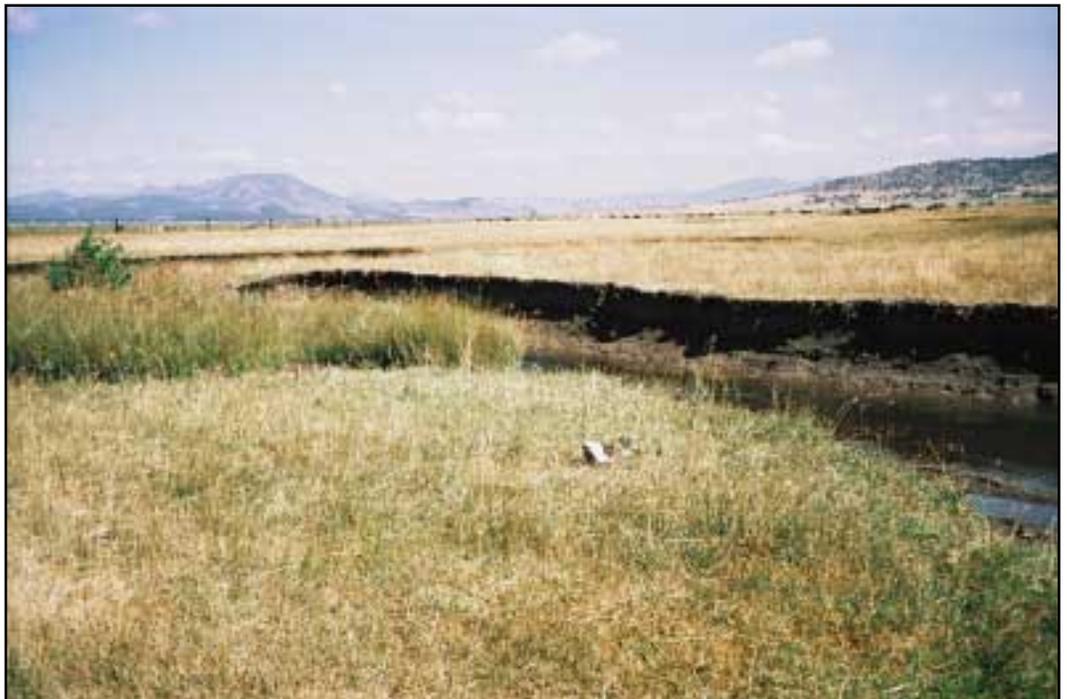
Figure 3. Channel condition. Evidence of past downcutting is one of the factors indicating a score of 8. See figures 2, 15, and 16 for more examples of scoring channel condition.

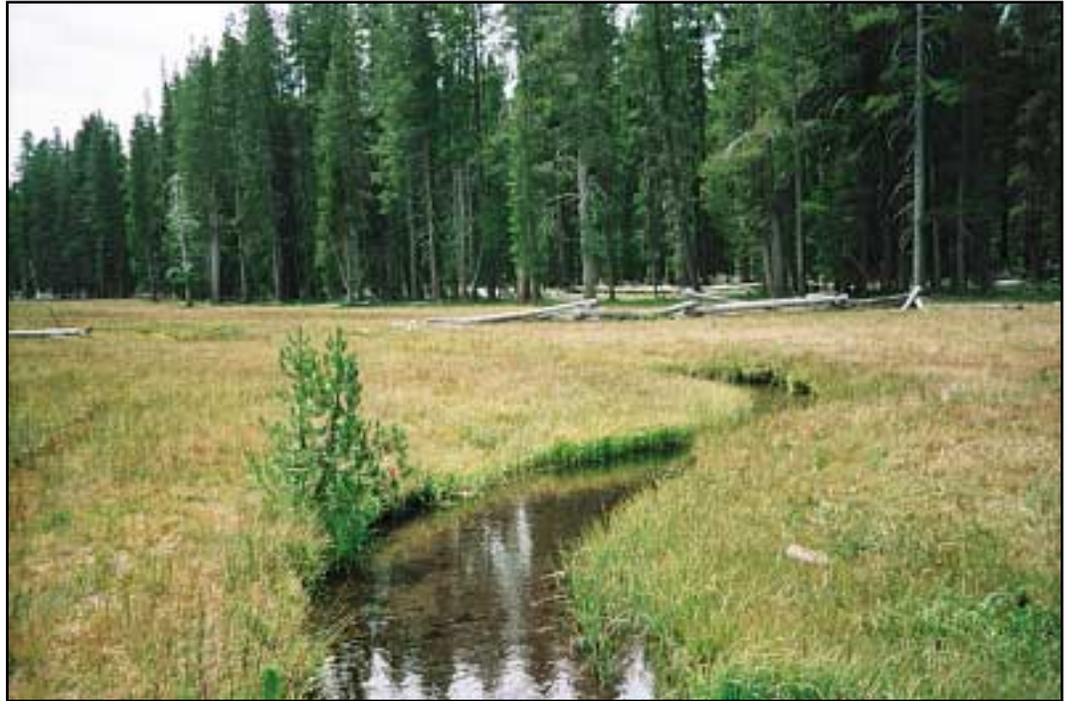
Figure 4. Access to floodplain. This site scores a perfect 12. See figures 5, 17, and 18 for more examples of scoring access to floodplain.

This question determines how often a creek exceeds bankfull. A creek should exceed bankfull every 1½ to 2 years, even if only briefly. This can be linked to Question 1. If a channel has been downcut, it will not have access to its normal floodplain (NRCS: $p=0.005$, $R^2=0.998$).

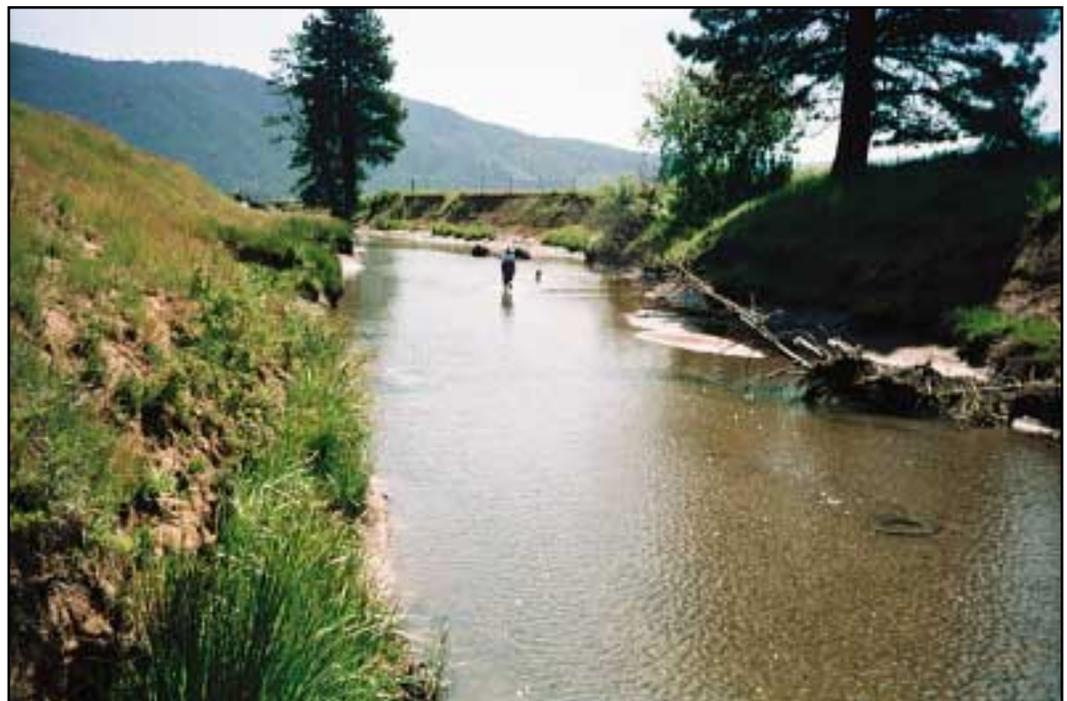
Figure 5. Access to floodplain. This creek receives a score of 1 because it is deeply incised and does not flood. See figures 4, 17, and 18 for more examples of scoring access to floodplain.

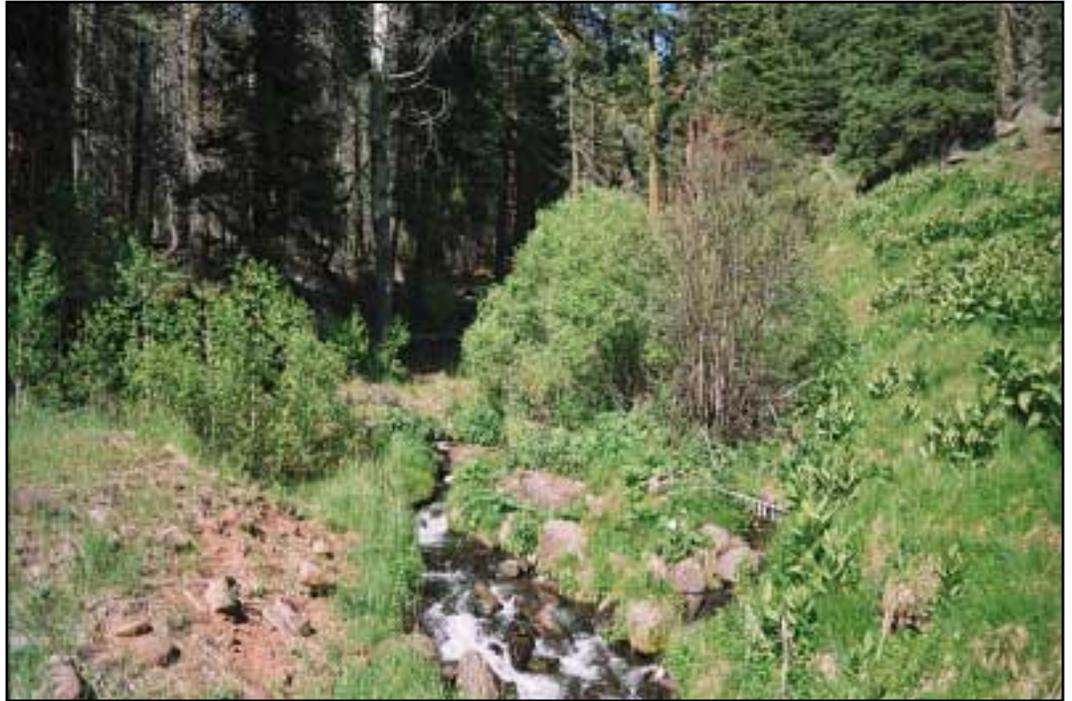
Figure 6. Bank stability. This site scores a 12 (6 for each bank). See figures 7, 19, and 20 for more examples of scoring bank stability.

This question was present in some form on all four existing assessments. Bank stability is important for healthy, functioning creeks (NRCS: $p < 0.001$, $R^2 = 0.998$; EPA: $p = 0.001$, $R^2 = 0.997$). Scoring banks separately allows for documentation of the condition of each one. For instance, if the right bank is actively eroding while the left bank is stable, assigning one score for the two together does not indicate an accurate assessment, while scoring each bank independently does. This also allows for improvements made on one bank to be more apparent in the future.

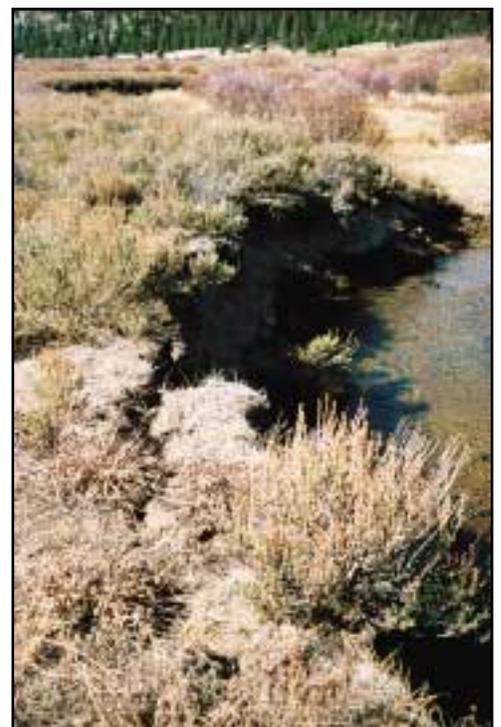
Figure 7. Bank stability. Active bank sloughing indicates a score of 2. See figures 6, 19, and 20 for more examples of scoring bank stability.

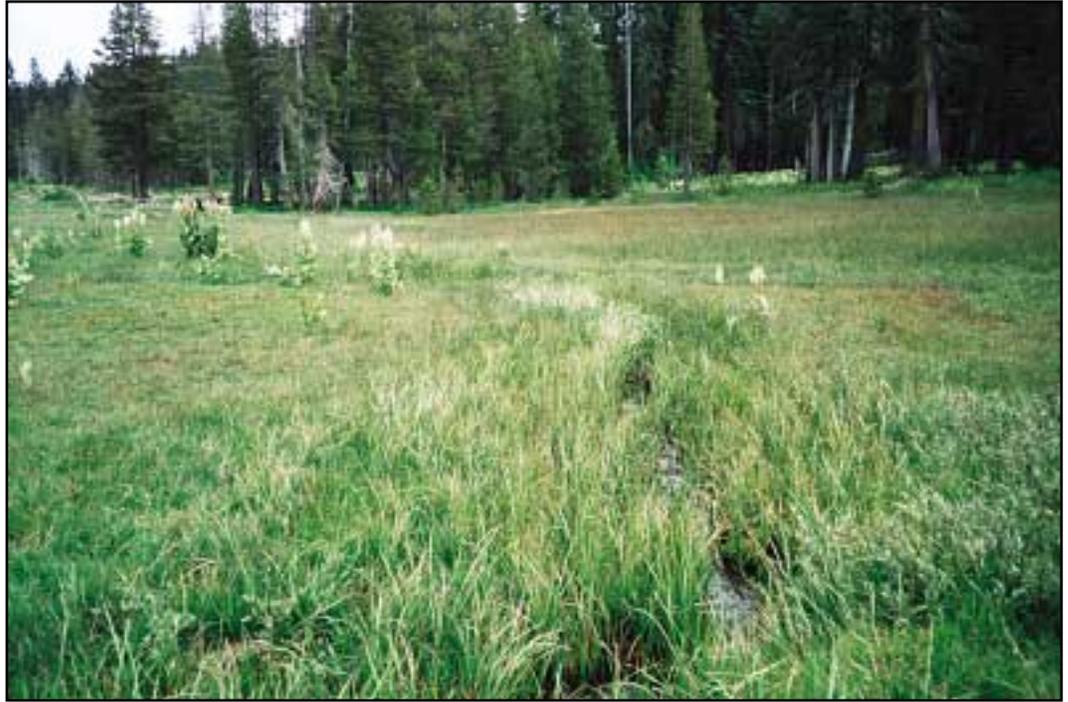
Figure 8. Riparian zone—perennial creek. This site scores a perfect 12. See figure 9 for another example of scoring the riparian zone of a perennial creek. See figures 21 and 22 for examples of scoring the riparian zone of annual systems.

Divided into perennial and intermittent creeks, riparian vegetation plays an important part in the health of a creek, providing root mats that can withstand high streamflow events (PFC: $p=0.007$, $R^2=0.757$), protect banks, and dissipate energy (PFC: $p<0.001$, $R^2=0.757$), as well as filter overland runoff of sediment and nutrients. As with bank stability, each bank is scored separately.

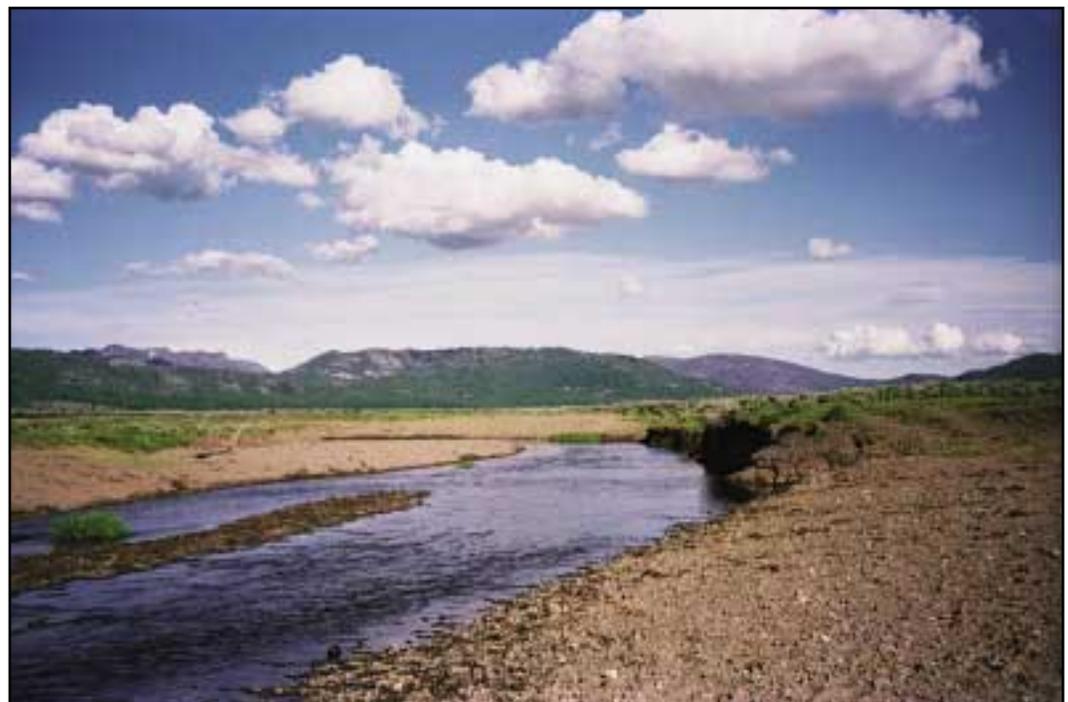
Figure 9. Riparian zone—perennial creek. Due to lack of vegetation, this creek scores a 1. See figure 8 for another example of scoring the riparian zone of a perennial creek. See figures 21 and 22 for annual systems.

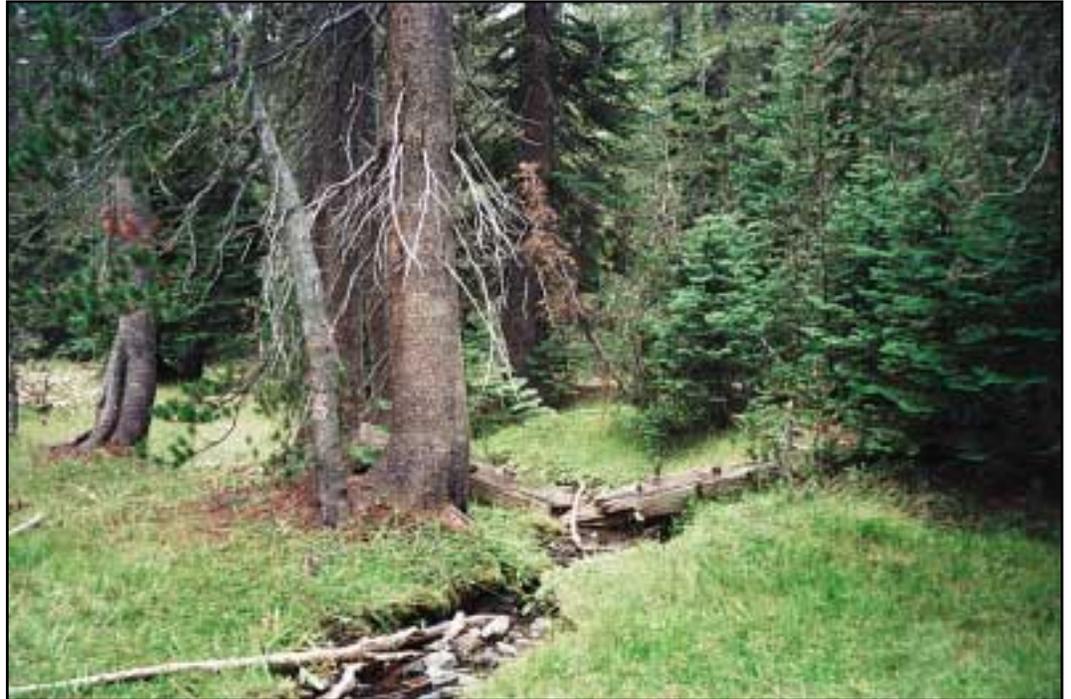
Figure 10.

Macroinvertebrate habitat. This site contains four habitat types: large woody debris, fine woody debris, cobbles, and undercut banks.

All creeks contain some macroinvertebrates. Therefore, it is important to examine the habitat available to them (EPA: $p < 0.001$, $R^2 = 0.997$). Possible habitats include cobbles, boulders, coarse gravel, and aquatic vegetation. To score this question, the types of habitats present are counted and categorized.

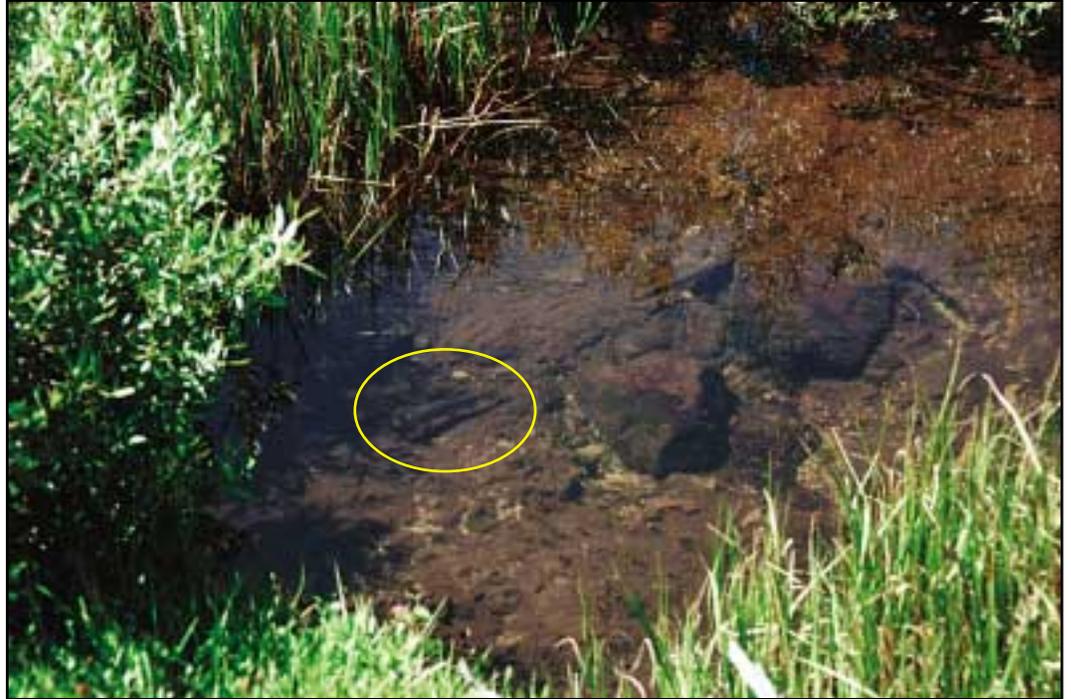
Figure 11. Fish habitat. This creek has a deep pool habitat with fish in it. See figures 12, 23, and 24 for more examples of fish habitat.

Not all of California's creeks and streams have the potential to support a fishery due to inadequate year-round flow, natural downstream obstructions such as waterfalls, and other natural factors. This question should be answered if it is reasonable to expect a fishery for the creek in question. Fish habitat is an important factor to consider (EPA: $p < 0.001$, $R^2 = 0.997$) and is scored similarly to macroinvertebrate habitat (Question 5), with possible habitat types including large woody debris, cobbles, boulders, aquatic vegetation, riffles, and so on.

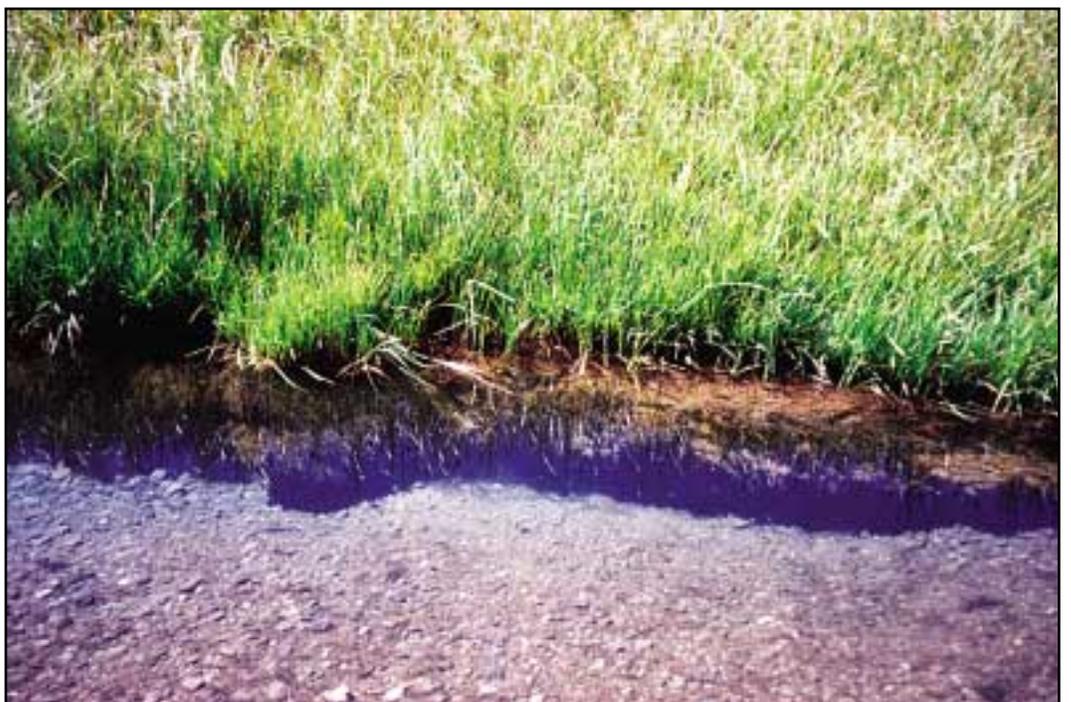
Figure 12. Fish habitat. This creek has a stable, undercut bank. See figures 11, 23, and 24 for more examples of fish habitat.

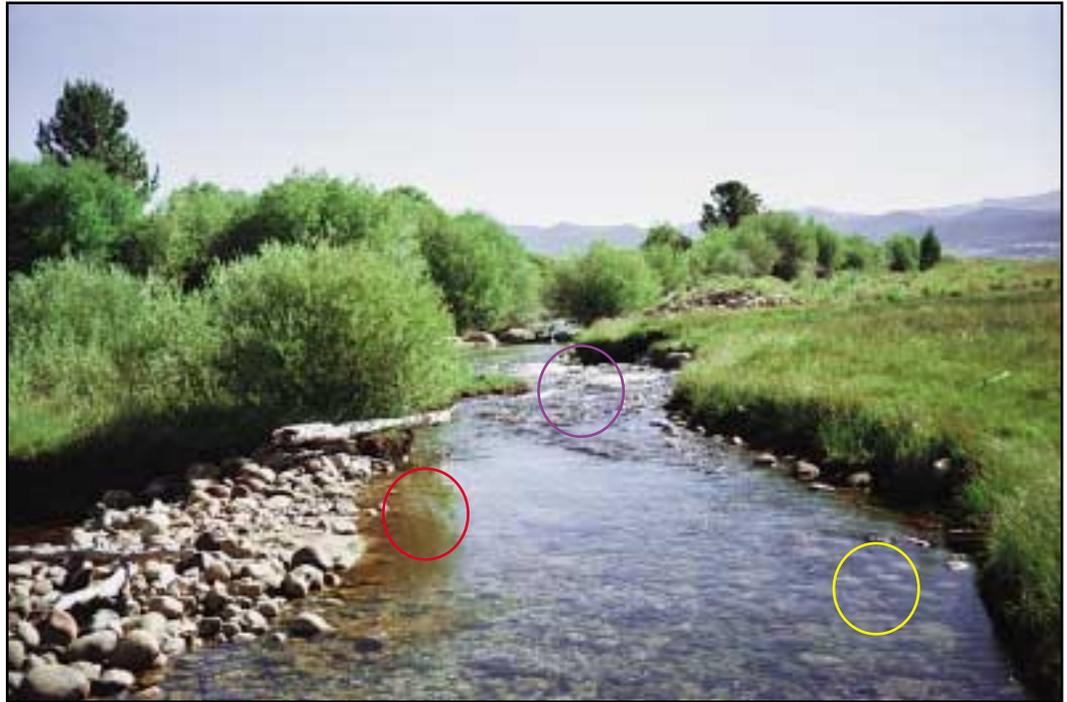
Figure 13. Velocity depth regime. A combination of fast-shallow (purple circle), fast-deep (yellow circle), and slow-shallow (red circle) regimes are present at this site.

High gradient creeks should have a variety of velocity depth regimes present, providing different habitat niches for various aquatic life. Fast-shallow sections add dissolved oxygen into the creek, and slow-deep sections allow fish cover out of the current. This question was again found to be a significant factor in stream health (EPA: $p < 0.001$, $R^2 = 0.997$).

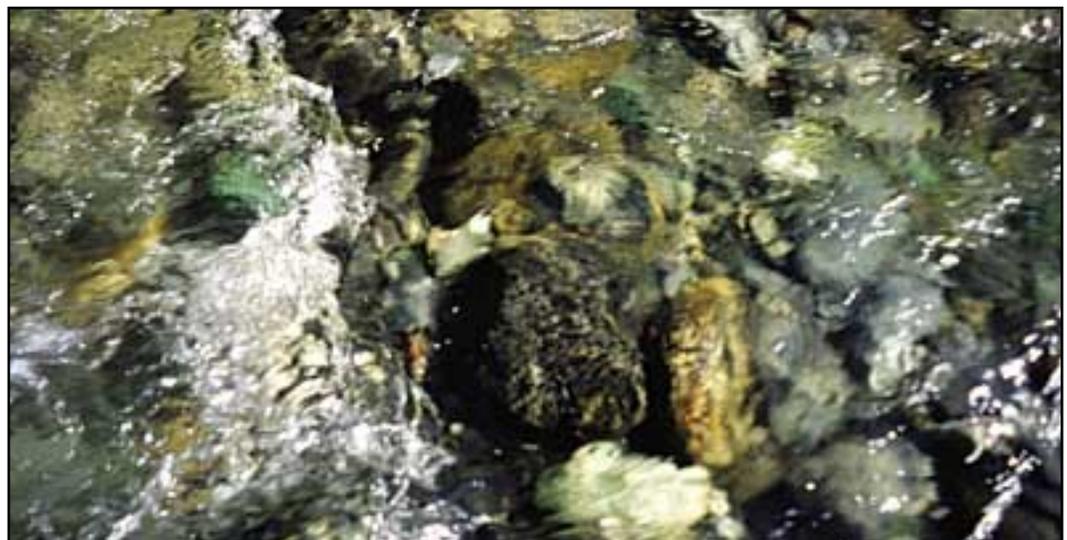
Figure 14. Riffle embeddedness. This creek shows a good example of a clean riffle.

High gradient creeks are dominated by riffles, important features in both dissipating velocity and providing habitat. To function properly, riffles should be free of sediment and the cobble and gravel substrate should not be embedded in the silts and clays. This question was evaluated by the percent of fines accumulating in the riffle (EPA: $p = 0.027$, $R^2 = 0.997$).

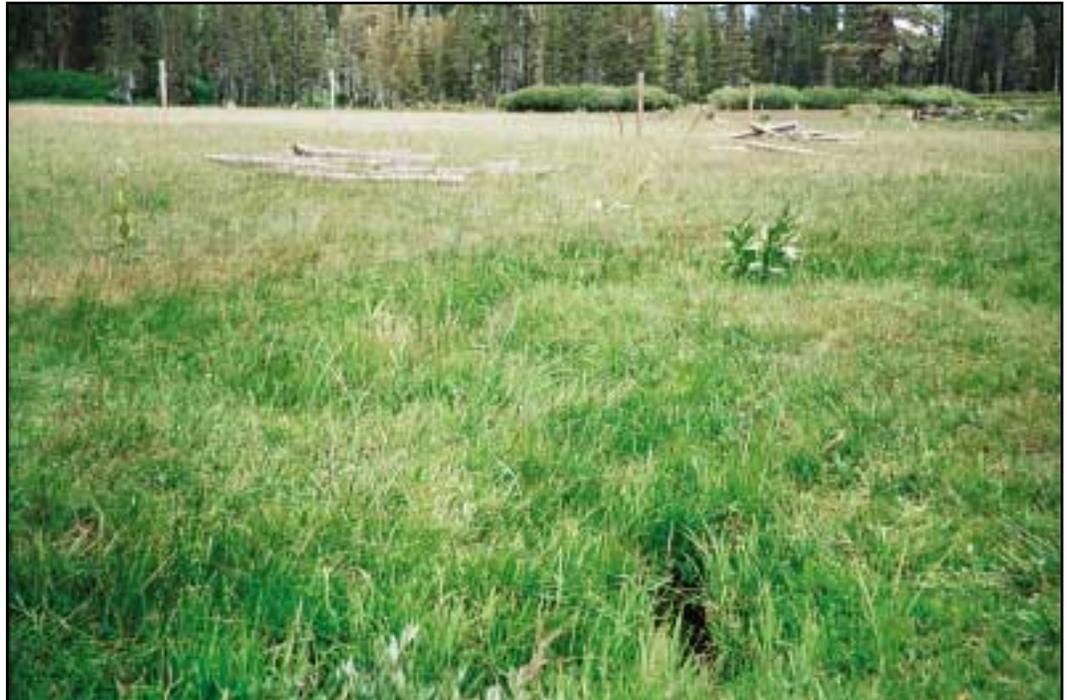
Figure 15. Channel condition. This site scores a 12 because this is the natural channel and there is no evidence of downcutting. See figures 2, 3, and 16 for more examples of scoring channel condition.

This question determines whether a creek has experienced downcutting in the past, restricting full utilization of the floodplain. The score is lower if there is active downcutting. A channel condition question was present on all assessments in some form. It was found to be significant (NRCS: $p=0.002$; EPA: $p<0.001$; PFC: $p<0.001$) at predicting habitat scores (NRCS: $R^2=0.996$; EPA: $R^2=0.996$; PFC: $R^2=0.774$).

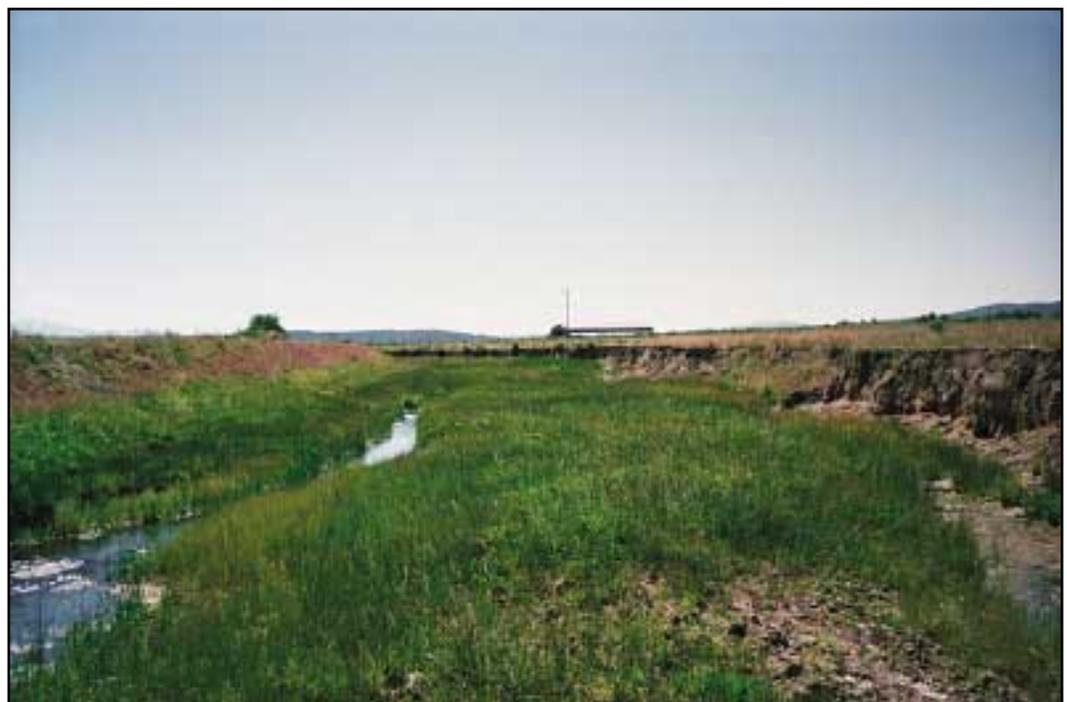
Figure 16. Channel condition. A score of 4 goes to this creek because the floodplain is restricted and downcutting has been extensive throughout the reach. See figures 2, 3, and 15 for more examples of scoring channel condition.

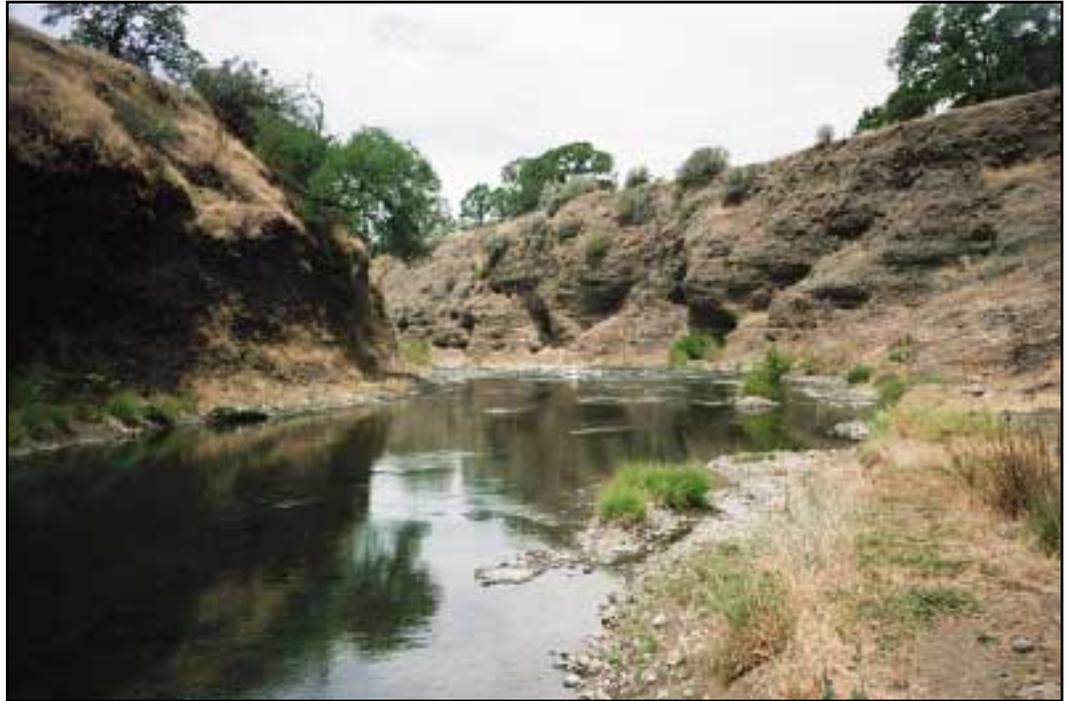
Figure 17. Access to floodplain. This creek scores a 7 due to limited flooding. Flooding only takes place with large storm systems that occur approximately every 10 to 15 years. See figures 4, 5, and 18 for more examples of scoring access to floodplain.

This question determines how often a creek exceeds bankfull. A creek should exceed bankfull every 1½ to 2 years, even if only briefly. This can be linked to Question 1. If a channel has been downcut, it will not have access to its normal floodplain. (PFC: $p < 0.001$, $R^2 = 0.774$)

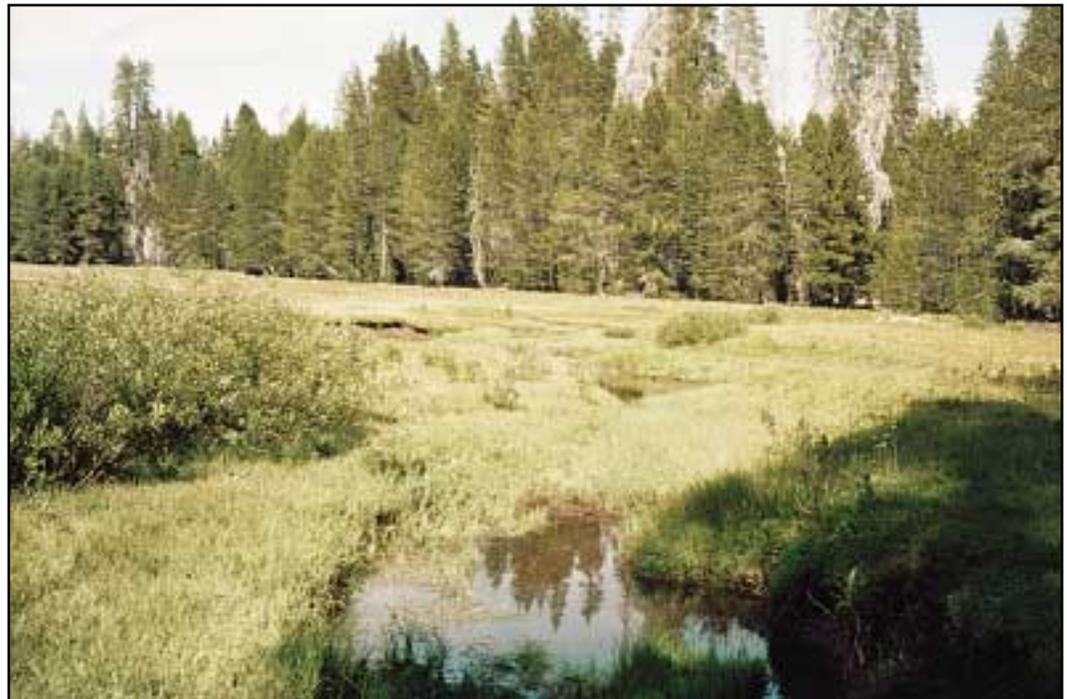
Figure 18. Access to floodplain. This site scores an 8 because there is a limited incision that reduces access to the floodplain to 3- to 5-year events. See figures 4, 5, and 17 for more examples of scoring access to floodplain.

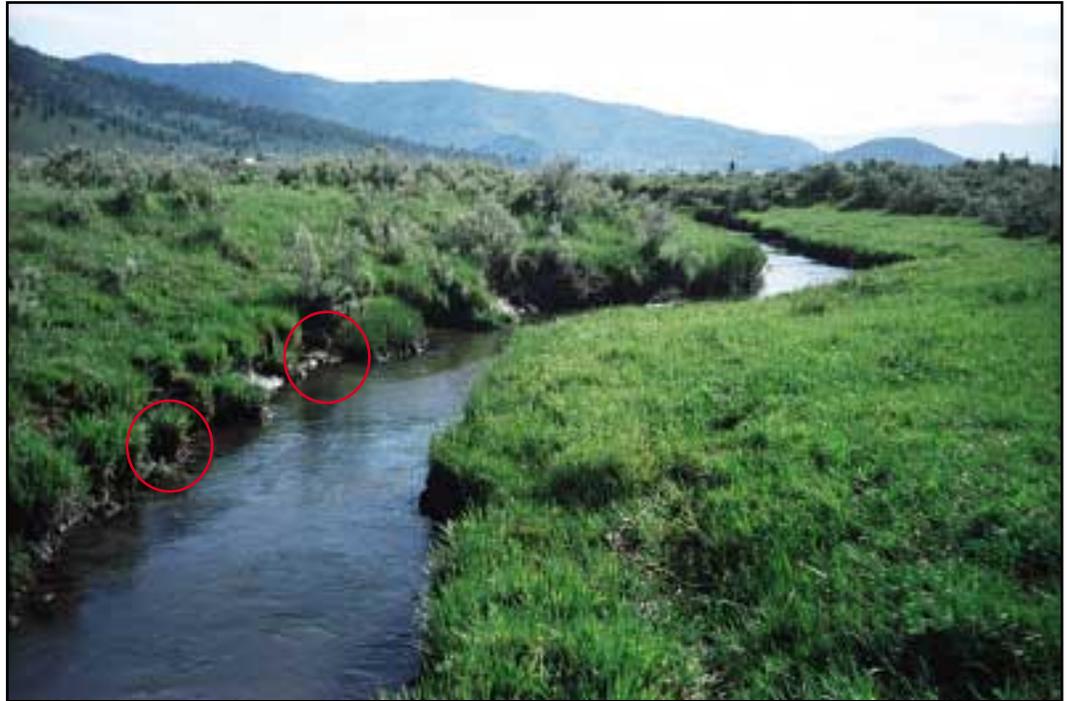
Figure 19. Bank stability. Because of the unstable areas circled in red, a score of 11 is given to this creek (6 for the right bank and 5 for the left bank). See figures 6, 7, and 20 for more examples of scoring bank stability.

This question was present in some form on all existing assessments. Bank stability is important for healthy, functioning creeks (NRCS: $p < 0.001$, $R^2 = 0.996$; EPA: $p < 0.001$, $R^2 = 0.996$). Scoring banks separately allows for documentation of the condition of each one. For instance, if the right bank is actively eroding while the left bank is stable, assigning one score for the two together does not indicate an accurate assessment while scoring each bank independently does. This also allows for improvements made on one bank to be more apparent in the future.

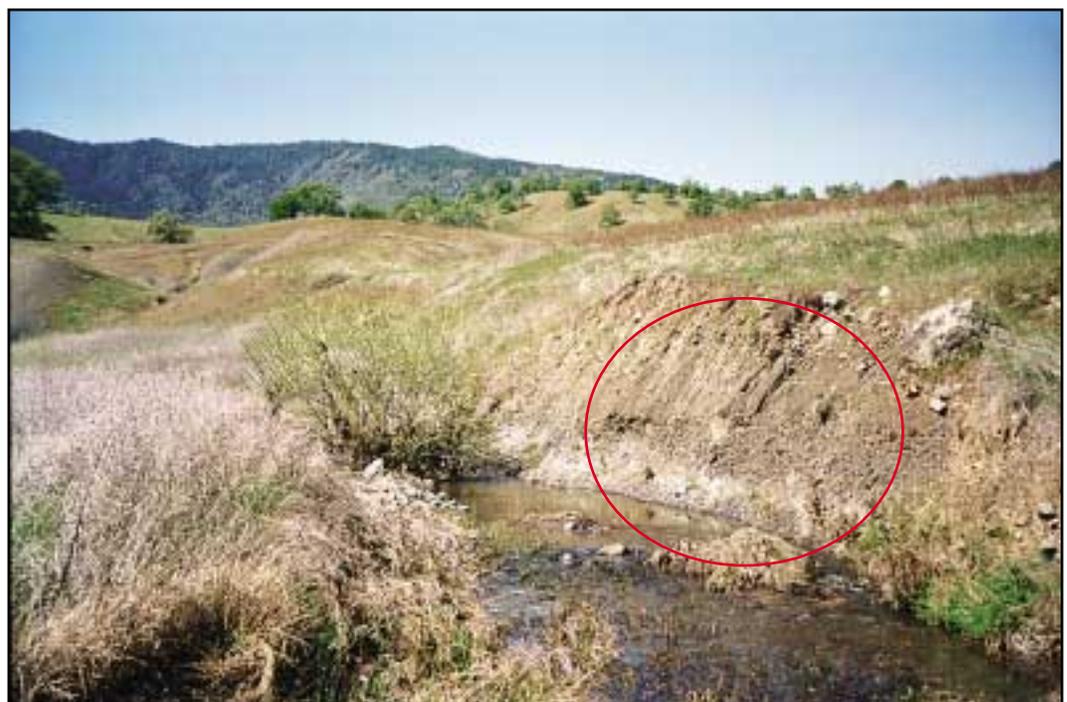
Figure 20. Bank stability. Because of the unstable area circled in red, this site scores 8.5 (3 for the eroding left bank and 5.5 for the stable right bank). See figures 6, 7, and 19 for more examples of scoring bank stability.

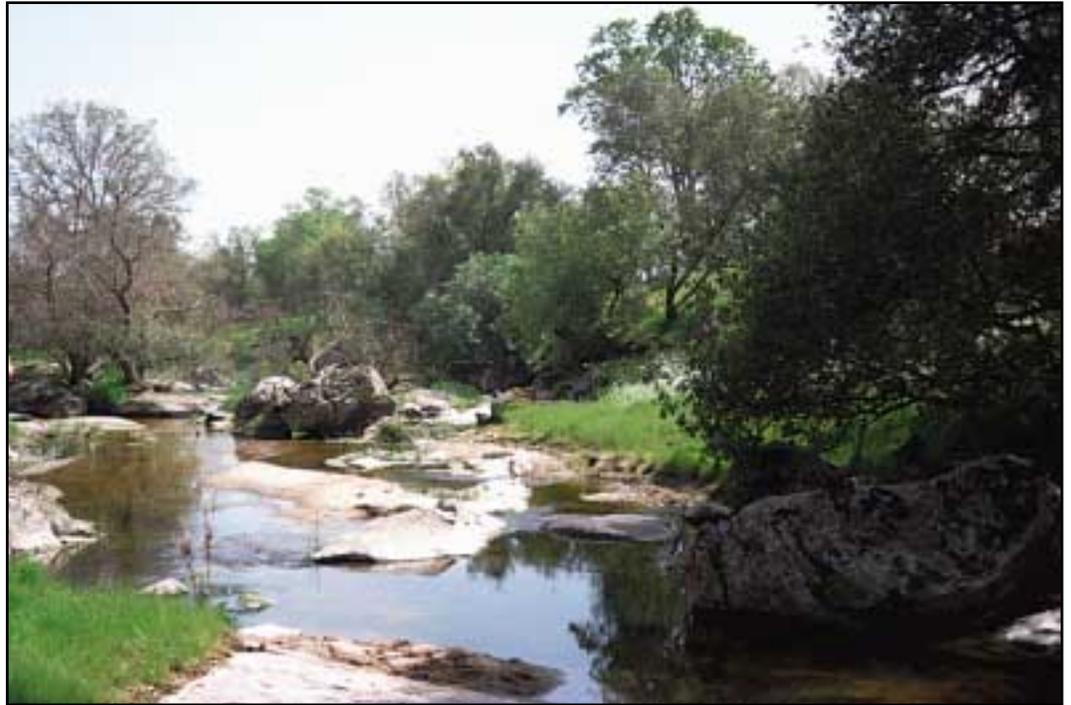
Figure 21. Riparian zone—intermittent creek. This creek scores an 11 (left bank: 5; right bank: 6), noting the bare sand bars. See figure 22 for more on scoring the riparian zone of an intermittent creek, and figures 8 and 9 for perennial systems.

Divided into perennial and intermittent creeks, riparian vegetation plays an important part in the health of a creek, protecting banks and dissipating energy (NCRS: $p=0.001$, $R^2=0.996$; PFC: $p<0.001$, $R^2=0.774$), as well as filtering overland runoff of sediment and nutrients. It is also important that a diverse age class (PFC: $p=0.020$, $R^2=0.774$) and a diverse composition (PFC: $p=0.038$, $R^2=0.774$) be present. Revegetating point bars are also an upward sign of riparian health (PFC: $p<0.001$, $R^2=0.774$). As with bank stability, each bank is scored separately.

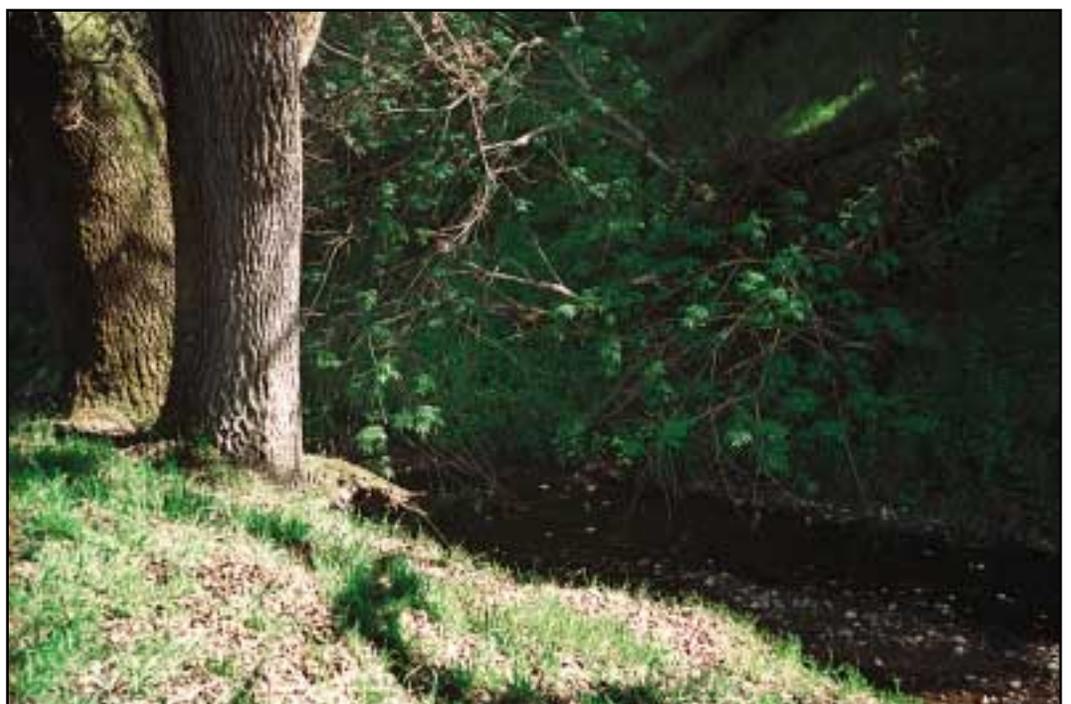
Figure 22. Riparian zone—intermittent creek. Due to the bare gravel bars, this creek scores a 10 (left bank: 4.5; right bank: 5.5). See figure 21 for more on scoring the riparian zone of an intermittent creek, and figures 8 and 9 for perennial systems.

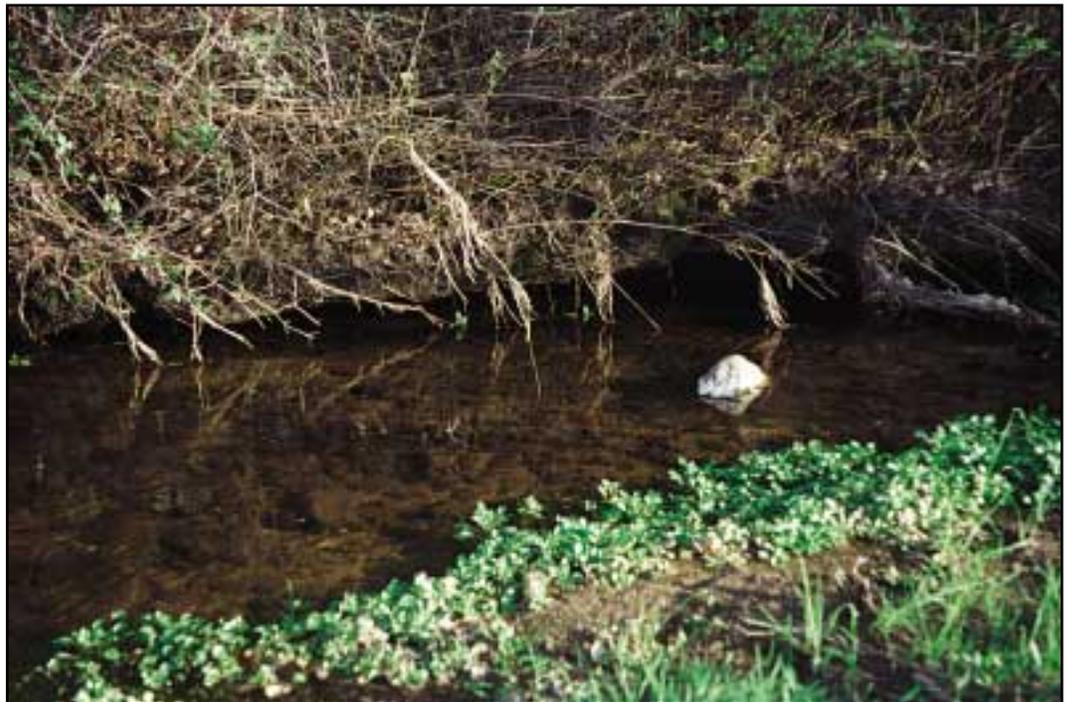
Figure 23. Fish habitat. A stable, undercut bank is a good fish habitat. See figures 11, 12, and 24 for more examples of fish habitat.

Not all of California's creeks and streams have the potential to support a fishery due to inadequate year-round flow, natural downstream obstructions such as waterfalls, and other natural factors. This question should be answered if it is reasonable to expect a fishery for the creek in question. Fish habitat is an important factor to consider (NRCS: $p < 0.001$, $R^2 = 0.996$; EPA: $p < 0.001$, $R^2 = 0.996$) and is scored similarly to macroinvertebrate habitat (Question 5), with possible habitat types including large woody debris, cobbles, boulders, aquatic vegetation, and riffles.

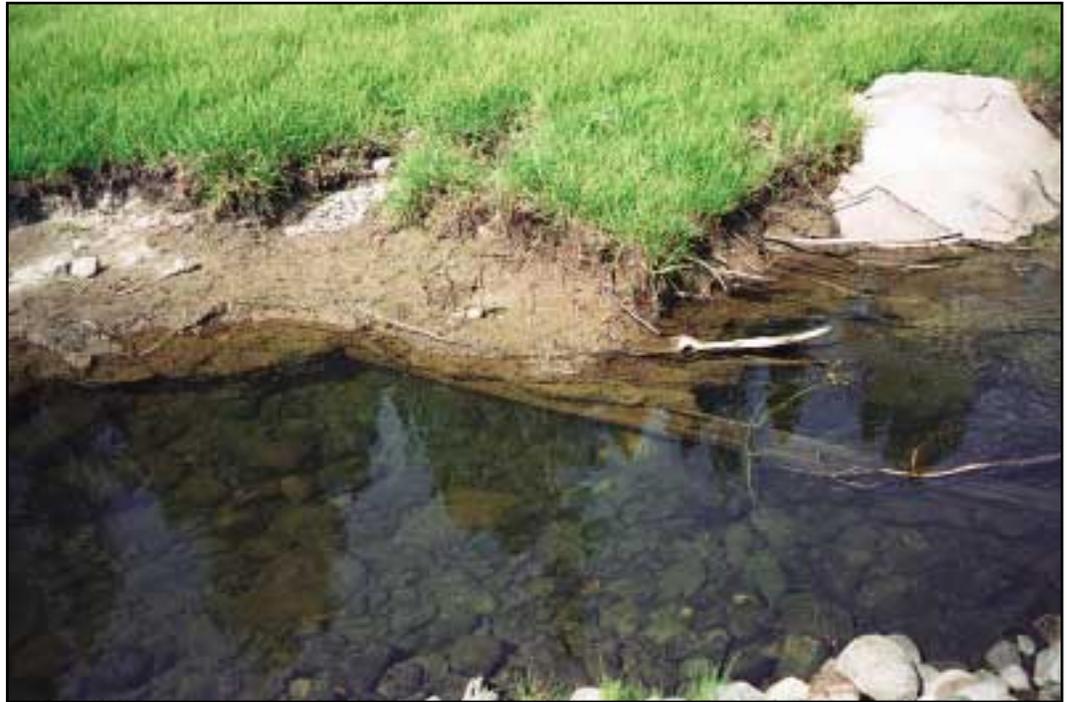
Figure 24. Fish habitat. A deep pool and large woody debris are good habitats for fish. See figures 11, 12, and 23 for more examples of fish habitat.

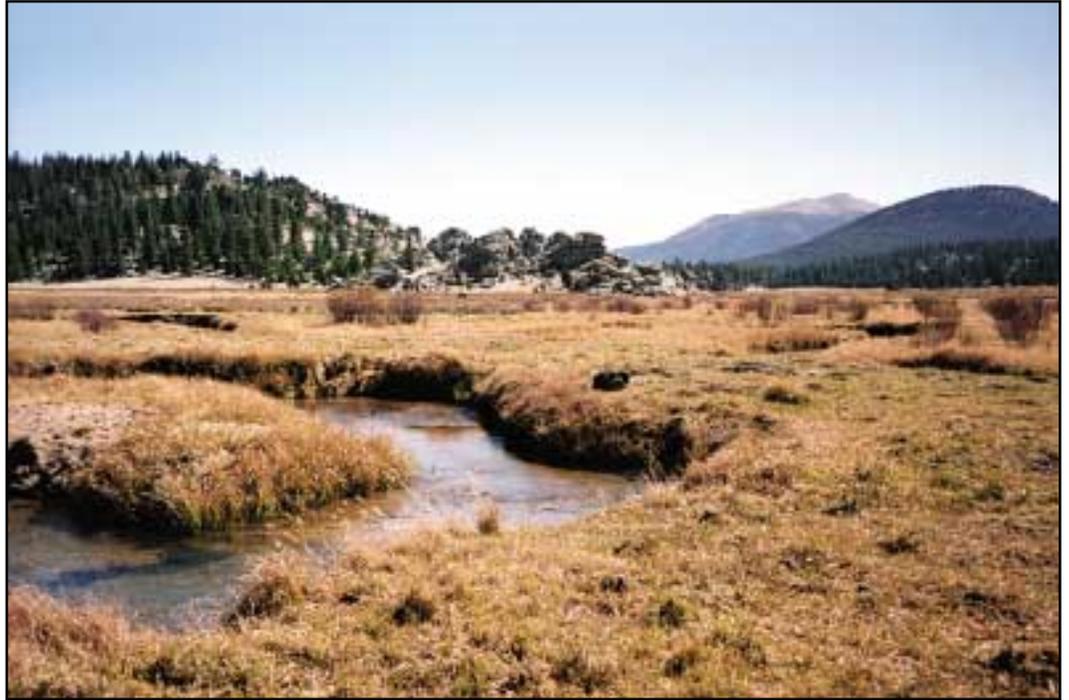
Figure 25. Channel flow. This site scores a 12 because of its full flow. See figure 26 for another example of scoring channel flow.

Even while considering that channel flow varies depending on the time of year, it is still an important factor to monitor (EPA: $p < 0.001$, $R^2 = 0.996$). When water does not fill the majority of the channel, substrate can be exposed, limiting both fish and macroinvertebrate habitat potential. For intermittent or ephemeral creeks, the assessment should be completed while there is still a flowing creek.

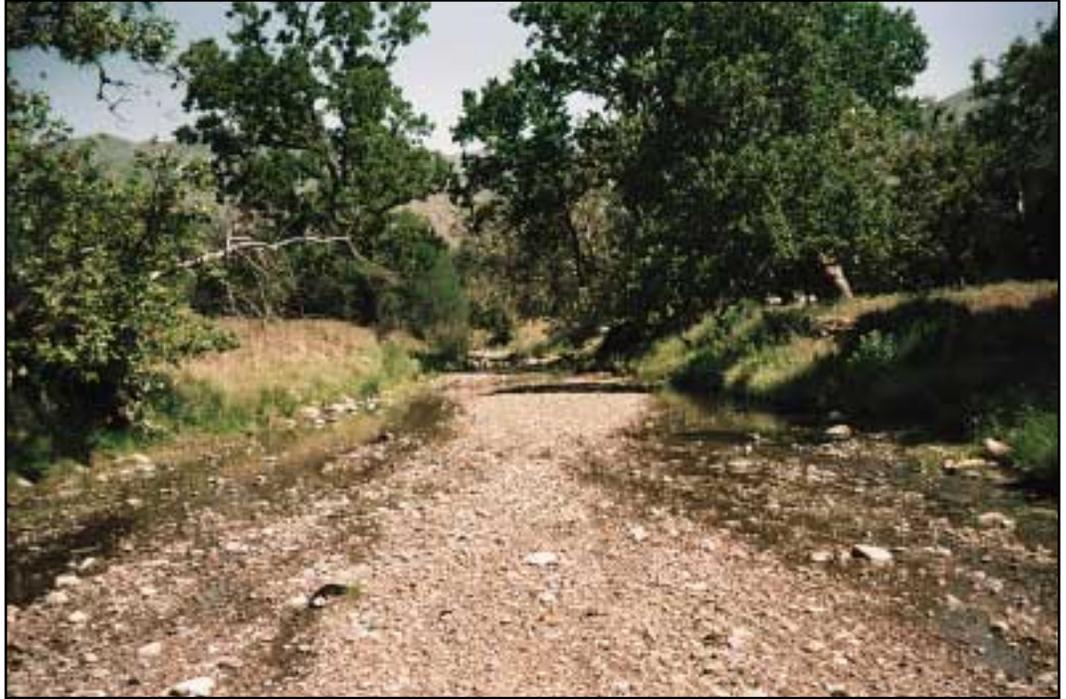
Figure 26. Channel flow. This creek has low channel flow. It scores a 3. See figure 25 for another example of scoring channel flow.
